Coastal Flooding New Forest to Hayling Island

9th April 2024

Section 19 Flood Investigation Report

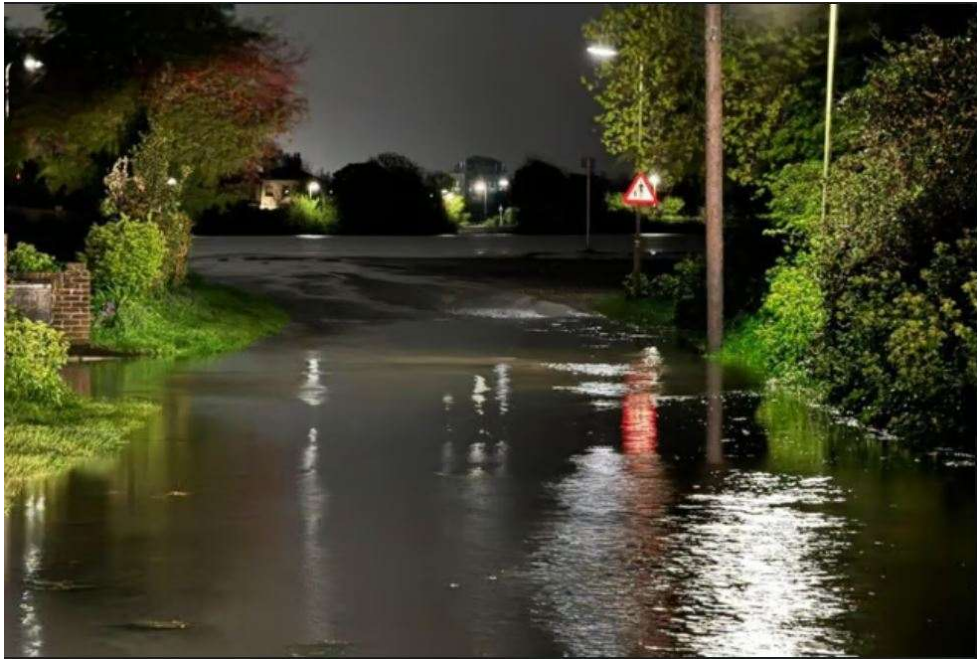
5.1.2. Hampshire County Council, as LLFA and Hampshire Highways, received reports of flooding at Anglesey Road and Park Road in Alverstoke. Hampshire Highways were contacted by emergency services at 00:47am Tuesday 9th April 2024, with roads closed due to flooding. The closures were at the junction of Little Anglesey Road (see figures 5 and 6) and St Marks Road, and at Village Road.

Figure 5: Anglesey Road, 9th April 2024 (Source: Coastal Partners)

5.1.4. A secondary impact of the sea wall overtopping was that Southern Water's surface water pumping station was inundated with sea water, overwhelmed and was unable to cope with the additional demand. Southern Water deployed 600 sandbags to help protect the pumping station. They also worked in partnership with Hampshire Highways to sandbag access routes and to help protect properties. Southern Water deployed their customer services team to support impacted residents and made additional sandbags available if required.

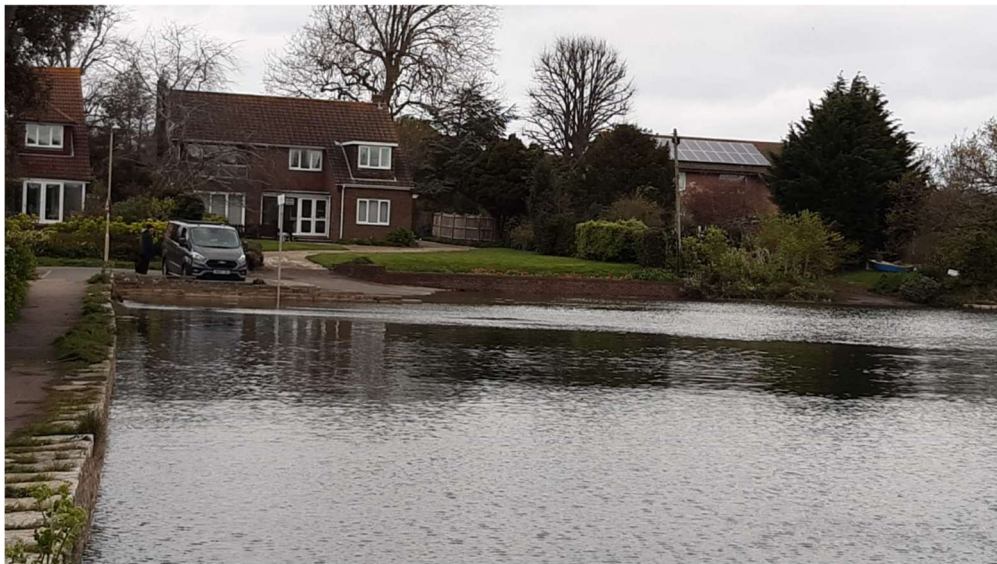
Figure 6: Anglesey Road, 9th April 2024 (Source: Hampshire & Isle of Wight Fire Rescue Service).

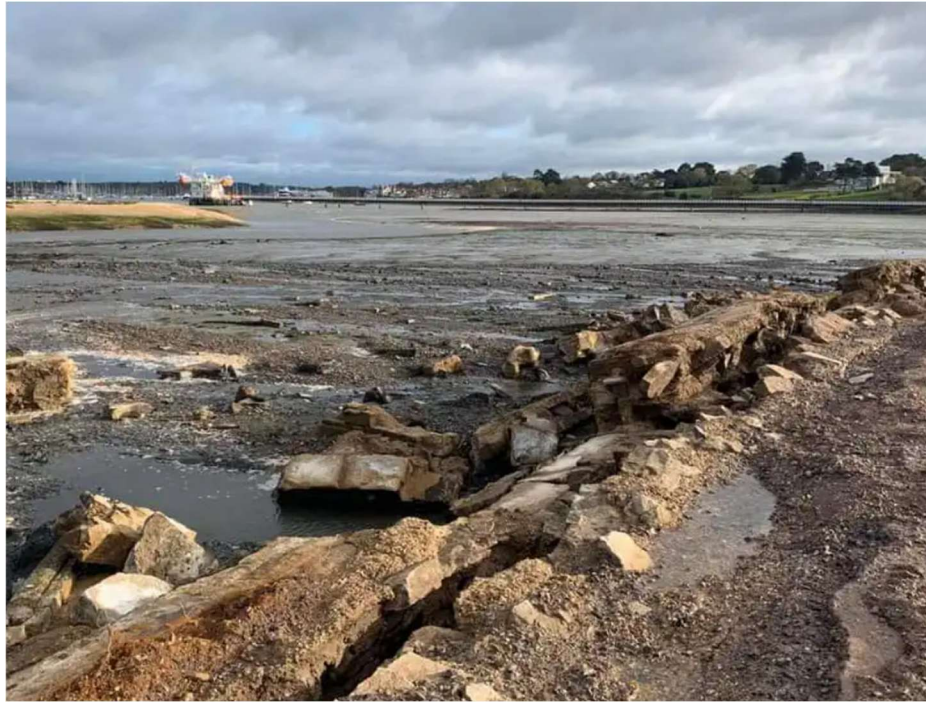
Figure 8: Hook Lake sea wall collapse (Source: Coastal Partners)

5.2.4. The Environment Agency recorded the nearby tide level in Hamble at a record high of 2.87m AOD. It was this exceptionally high level which caused the collapse of the sea defence.

5.2.2. The road flooding and the debris deposited on Hook Park Road bridge left 60 properties unable to use the main access road. Hampshire Highways attended to clear the debris from the bridge and arranged for it to be inspected for structural damage. Until the sea wall is repaired, Hampshire Highways are prepared to manage future debris deposits during high tides.

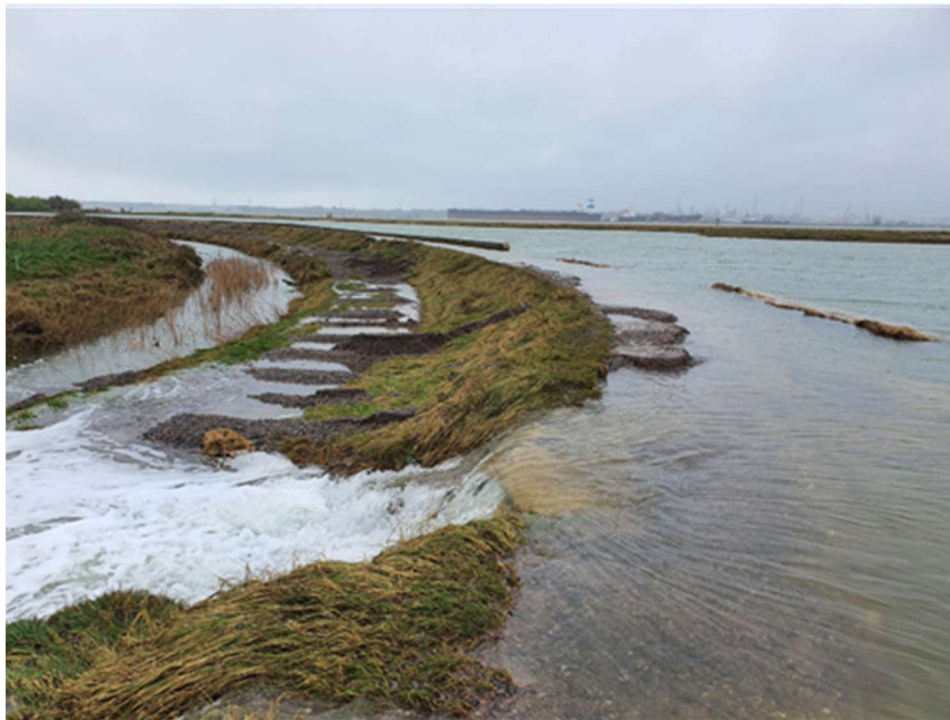
Figure 9: Hook Lake sea wall collapse (Source: Hampshire Highways)

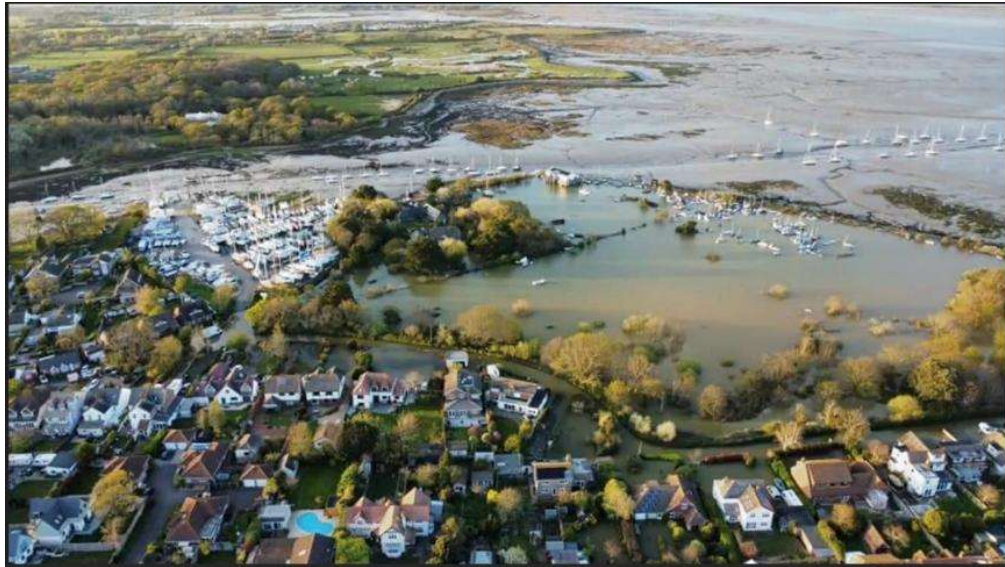
Figure 12: Drone imagery provided by the Environment Agency

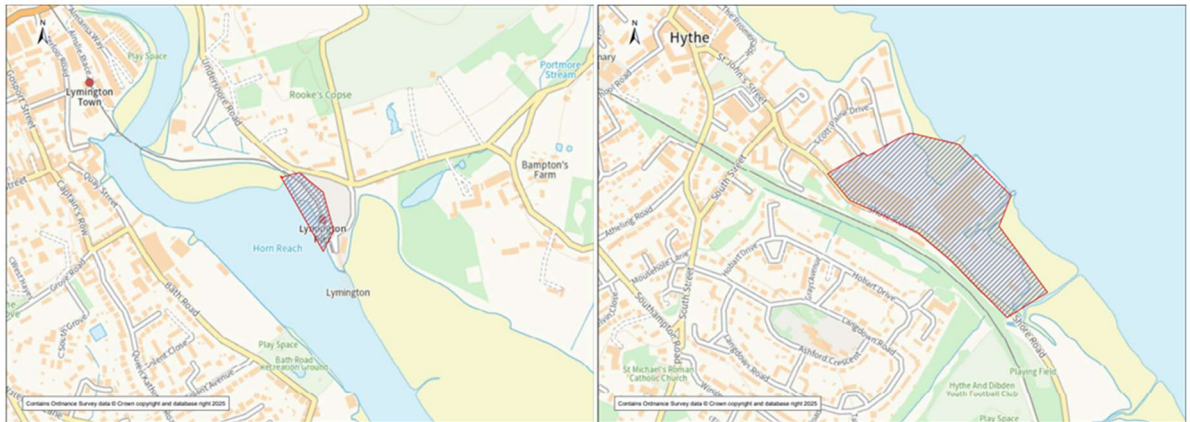
Figure 15: Approximate area of flooding – New Forest

5.6.1. The following map highlights the approximate areas of flooding in the New Forest area.

5.6.3. Flooding was forecast by the Environment Agency in Hythe and the Beaulieu Estuary. Flood gates were closed in Keyhaven and Lymington. The tide level measured in Lymington was third highest ever recorded. No reports of properties flooded by this event have been received. However, information sourced from local media identify Shore Road, Hythe and Hythe Marine Park were flooded with several premises inundated, including the Fire-Aid Academy.
